**Flood Control Project Maintenance
Levee Inspections**

Maintenance Issue Types Only, Levee Inspection Report By Mile - Spring 2017

Reclamation District No. 0070 Meridian

Waterway	Bank	Unit Miles	Inspection Start/End	Inspector
Unit No. 01 Sutter Bypass	Right	7.92	04/06/2017 04/06/2017	Bob Duffey

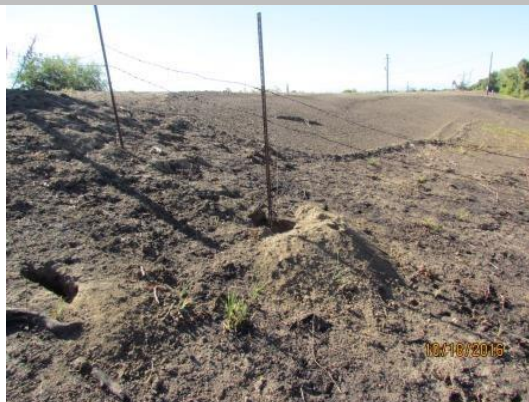
Photo 1 of 1 : SP_2017_RD0070_29_32_20170315_00007.jpg

LM Start	1.77	Rating **	M	Issue No.	32
LM End	1.77	Issue Type +	Ma	Location *	LS
Category	Earthen Levee			GPS Latitude/Longitude	
				Start	End
Item	Animal Control			39.151282 °	39.151282 °
				-121.855818 °	-121.855818 °
DWR ID	DWR_RD0070_01_f_2016_32				
Comment Code					
A1 : Exterminate rodents and backfill and compact or grout burrows.					
Inspector Comment

View of the rodent holes along the waterside slope.

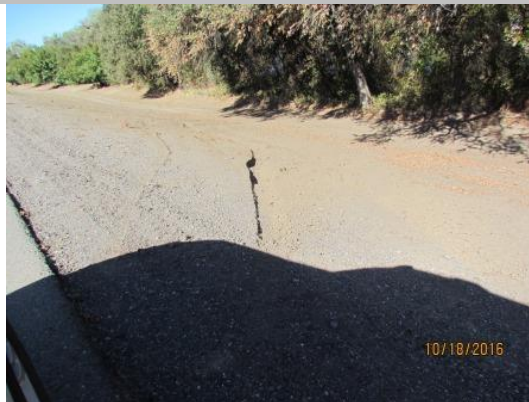
Photo 1 of 1 : SP_2017_RD0070_29_29_20170315_00004.jpg

LM Start	3.72	Rating **	M	Issue No.	29
LM End	3.72	Issue Type +	Ma	Location *	WS
Category	Earthen Levee			GPS Latitude/Longitude	
				Start	End
Item	Slope Stability			39.158183 °	39.158183 °
				-121.888397 °	-121.888397 °
DWR ID	DWR_RD0070_01_f_2016_29				
Comment Code					
S3 : Repair the levee slope damaged by vehicle traffic and prevent access where possible.					
Inspector Comment

View of the ruts along the waterside slope.

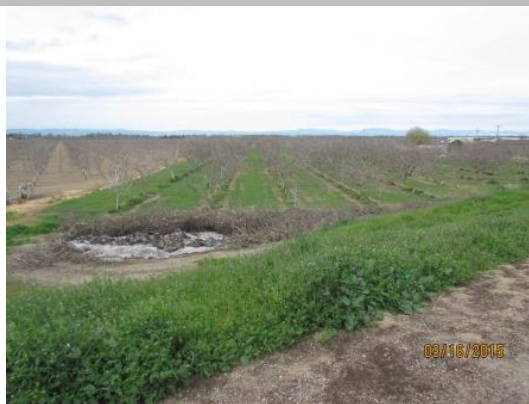
Photo 1 of 1 : SP_2017_RD0070_29_34_20170315_00009.jpg

LM Start	4.57	Rating **	M	Issue No.	34
LM End	4.57	Issue Type +	Ma	Location *	LS
Category	Earthen Levee			GPS Latitude/Longitude	
				Start	End
Item	Encroachments			39.167168 °	39.167168 °
				-121.899102 °	-121.899102 °
DWR ID	DWR_RD0070_01_s_2015_34				
Comment Code					
PR : Prunings					
Inspector Comment					
Remove the prunings from landside toe.

View of the prunings along the landside toe.

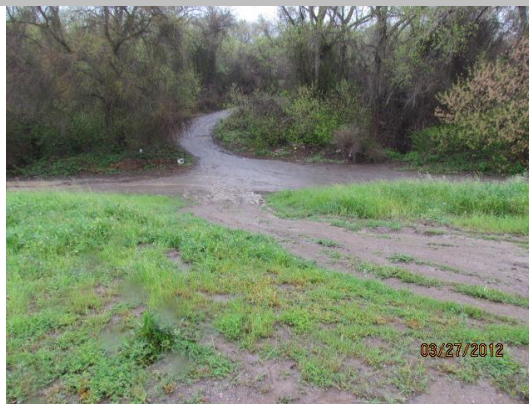
Photo 1 of 2 : SP_2017_RD0070_29_6_20170315_00001.jpg

LM Start	6.18	Rating **	M	Issue No.	6	
LM End	6.18	Issue Type +	Ma	Location *	WS	
Category	Earthen Levee			GPS Latitude/Longitude		
				Start		End
Item	Slope Stability			39.187481 °		39.187481 °
				-121.910852 °		-121.910852 °
DWR ID	DWR_RD0070_01_s_2012_6					
Comment Code						
S3 : Repair the levee slope damaged by vehicle traffic and prevent access where possible.						
Inspector Comment

View of vehicle erosion along the waterside slope.

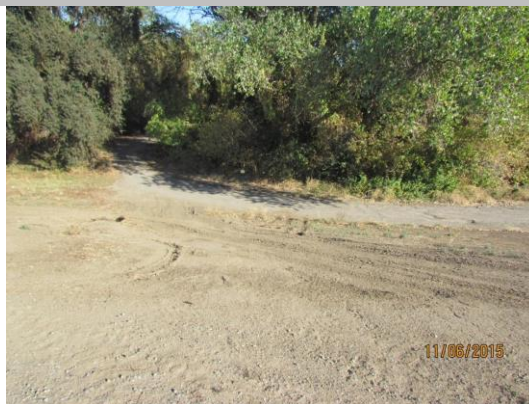
Photo 2 of 2 : SP_2017_RD0070_29_6_20170315_00002.jpg

LM Start	6.18	Rating **	M	Issue No.	6 (cont)
LM End	6.18	Issue Type +	Ma	Location *	WS

View of the vehicle erosion along the waterside slope.

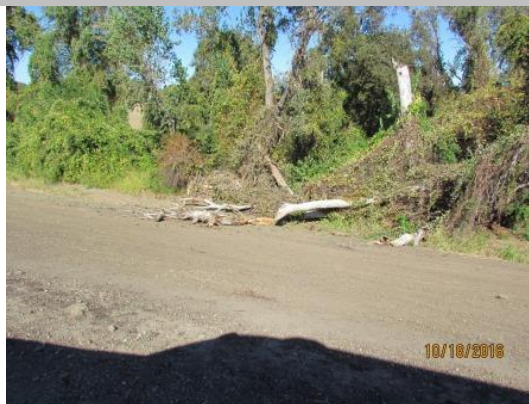
Photo 1 of 1 : SP_2017_RD0070_29_31_20170315_00006.jpg

LM Start	7.16	Rating **	M	Issue No.	31
LM End	7.16	Issue Type +	Ma	Location *	WS
Category	Earthen Levee			GPS Latitude/Longitude	
				Start	End
Item	Encroachments			39.196157 °	39.196157 °
				-121.922688 °	-121.922688 °
DWR ID	DWR_RD0070_01_f_2016_31				
Comment Code					
TR : Tree or limb					
Inspector Comment					
Remove the fallen tree.

View of a fallen tree along the waterside toe.

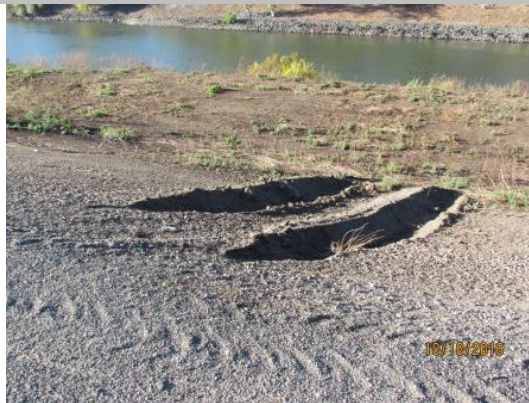
Photo 1 of 1 : SP_2017_RD0070_30_48_20170315_00005.jpg

LM Start	1.40	Rating **	M	Issue No.	48
LM End	1.40	Issue Type +	Ma	Location *	WS
Category	Earthen Levee			GPS Latitude/Longitude	
				Start	End
Item	Slope Stability			39.178369 °	39.178369 °
				-121.942657 °	-121.942657 °
DWR ID	DWR_RD0070_02_f_2016_48				
Comment Code					
S3 : Repair the levee slope damaged by vehicle traffic and prevent access where possible.					
Inspector Comment

View of the ruts along the waterside slope.

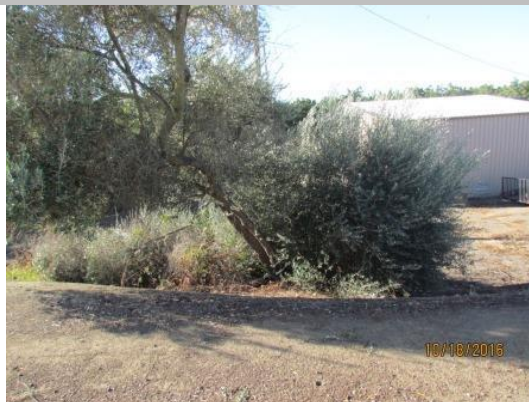
Photo 1 of 1 : SP_2017_RD0070_30_54_20170315_00008.jpg

LM Start	4.95	Rating **	M	Issue No.	54
LM End	4.95	Issue Type +	Ma	Location *	LS
Category	Earthen Levee			GPS Latitude/Longitude	
				Start	End
Item	Trim / Thin Trees			39.142016 °	39.142016 °
				-121.926214 °	-121.926214 °
DWR ID	DWR_RD0070_02_f_2016_54				
Comment Code					
T1 : Trim trees to at least five feet above ground level.					
Inspector Comment

View of the trees blocking visibility.

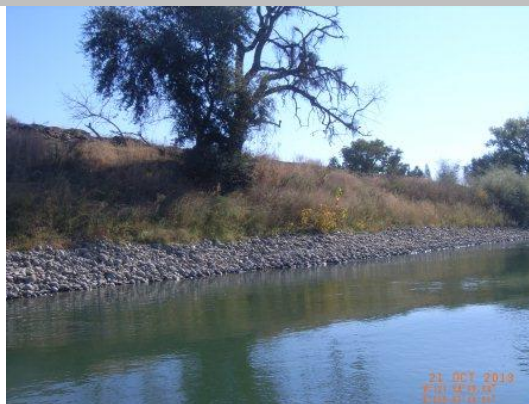
Photo 1 of 1 : SP_2017_RD0070_30_2_20170315_00002.jpg

LM Start	8.10	Rating **	M	Issue No.	2
LM End	8.23	Issue Type +	Ma	Location *	WS
Category	Supplemental			GPS Latitude/Longitude	
				Start	End
Item	2015 USACE Erosion Survey, DRAFT			39.122459 °	39.120684 °
				-121.910121 °	-121.909152 °
DWR ID	DWR_RD0070_02_s_2016_2				
Comment Code					
Inspector Comment					
1997 - Critical Site - Erosion of cobble site on outside of a bend. Failure caused by erosion of a material from behind the cobbles and cobbles rolling down the slope. Failure is just above the toe levee. Some repairs had been done at the upstream end. 2004 - Some minor new erosion at the top of the berm. 2005 - Trees look okay and the downstream end has some new rock repair. Site is no longer critical. 2006 - No longer critical, some repairs. 2015: No observed changes. [2015 Site ID: SAC_130-0_L]

USACE 2013 Photo #1

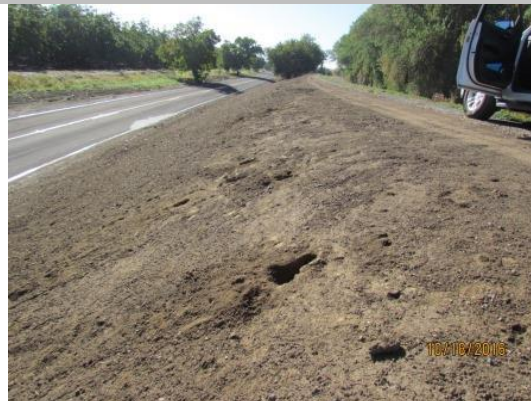
Photo 1 of 1 : SP_2017_RD0070_30_61_20170315_00012.jpg

LM Start	9.28	Rating **	M	Issue No.	61
LM End	9.28	Issue Type +	Ma	Location *	LS
Category	Earthen Levee			GPS Latitude/Longitude	
				Start	End
Item	Animal Control			39.107285 °	39.107285 °
				-121.900753 °	-121.900753 °
DWR ID	DWR_RD0070_02_f_2016_61				
Comment Code					
A3 : No rodents visible, but rodent burrows visible; need to backfill and compact or grout burrows.					
Inspector Comment

View of the rodent holes along the landside slope.

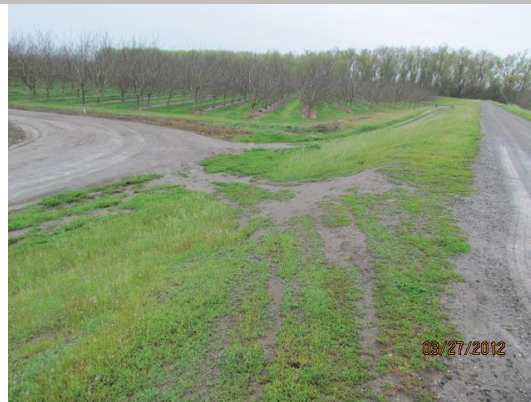
Photo 1 of 1 : SP_2017_RD0070_30_6_20170315_00003.jpg

LM Start	10.64	Rating **	M	Issue No.	6
LM End	10.64	Issue Type +	Ma	Location *	LS
Category	Earthen Levee			GPS Latitude/Longitude	
				Start	End
Item	Slope Stability			39.090300 °	39.090300 °
				-121.893102 °	-121.893102 °
DWR ID	DWR_RD0070_02_s_2012_6				
Comment Code					
S3 : Repair the levee slope damaged by vehicle traffic and prevent access where possible.					
Inspector Comment

View of vehicle erosion along landside slope.

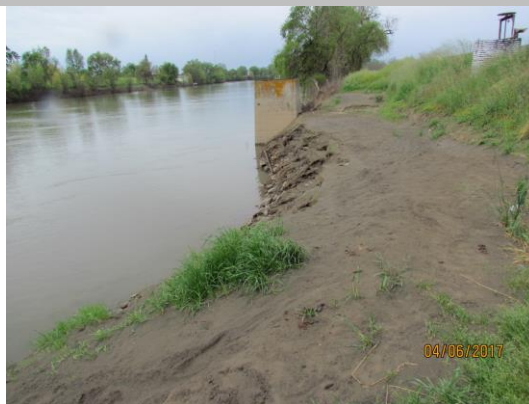
Photo 1 of 1 : SP_2017_RD0070_30_72_20170410_00122.jpg

LM Start	13.82	Rating **	U	Issue No.	72
LM End	13.82	Issue Type +	Ma	Location *	WS
Category	Earthen Levee			GPS Latitude/Longitude	
				Start	End
Item	Erosion / Bank Caving			39.068370 °	39.068370 °
				-121.862763 °	-121.862763 °
DWR ID	DWR_RD0070_02_s_2017_72				
Comment Code					
E2 : Schedule repair of erosion site prior to the next inspection.					
Inspector Comment					
Repair the erosion along the waterside slope.

View of the erosion along the waterside slope.

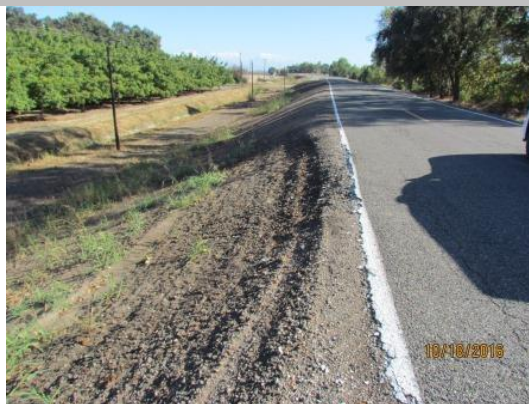
Photo 1 of 1 : SP_2017_RD0070_30_66_20170315_00015.jpg

LM Start	14.14	Rating **	M	Issue No.	66
LM End	14.14	Issue Type +	Ma	Location *	LS
Category	Earthen Levee			GPS Latitude/Longitude	
				Start	End
Item	Slope Stability			39.069849 °	39.069849 °
				-121.857267 °	-121.857267 °
DWR ID	DWR_RD0070_02_f_2016_66				
Comment Code					
S1 : Repair slope instability.					
Inspector Comment

View of slope instability along the landside slope.
